How cold-*in situ*-recycling pavement rehabilitation processes could improve circular economy results: Case study of a Spanish road

Daniel GARRAÍN*, Israel HERRERA, Yolanda LECHÓN

CIEMAT – Energy Systems Analysis Unit. Av. Complutense 40. E28040 Madrid (Spain). www.ciemat.es. *daniel.garrain@ciemat.es

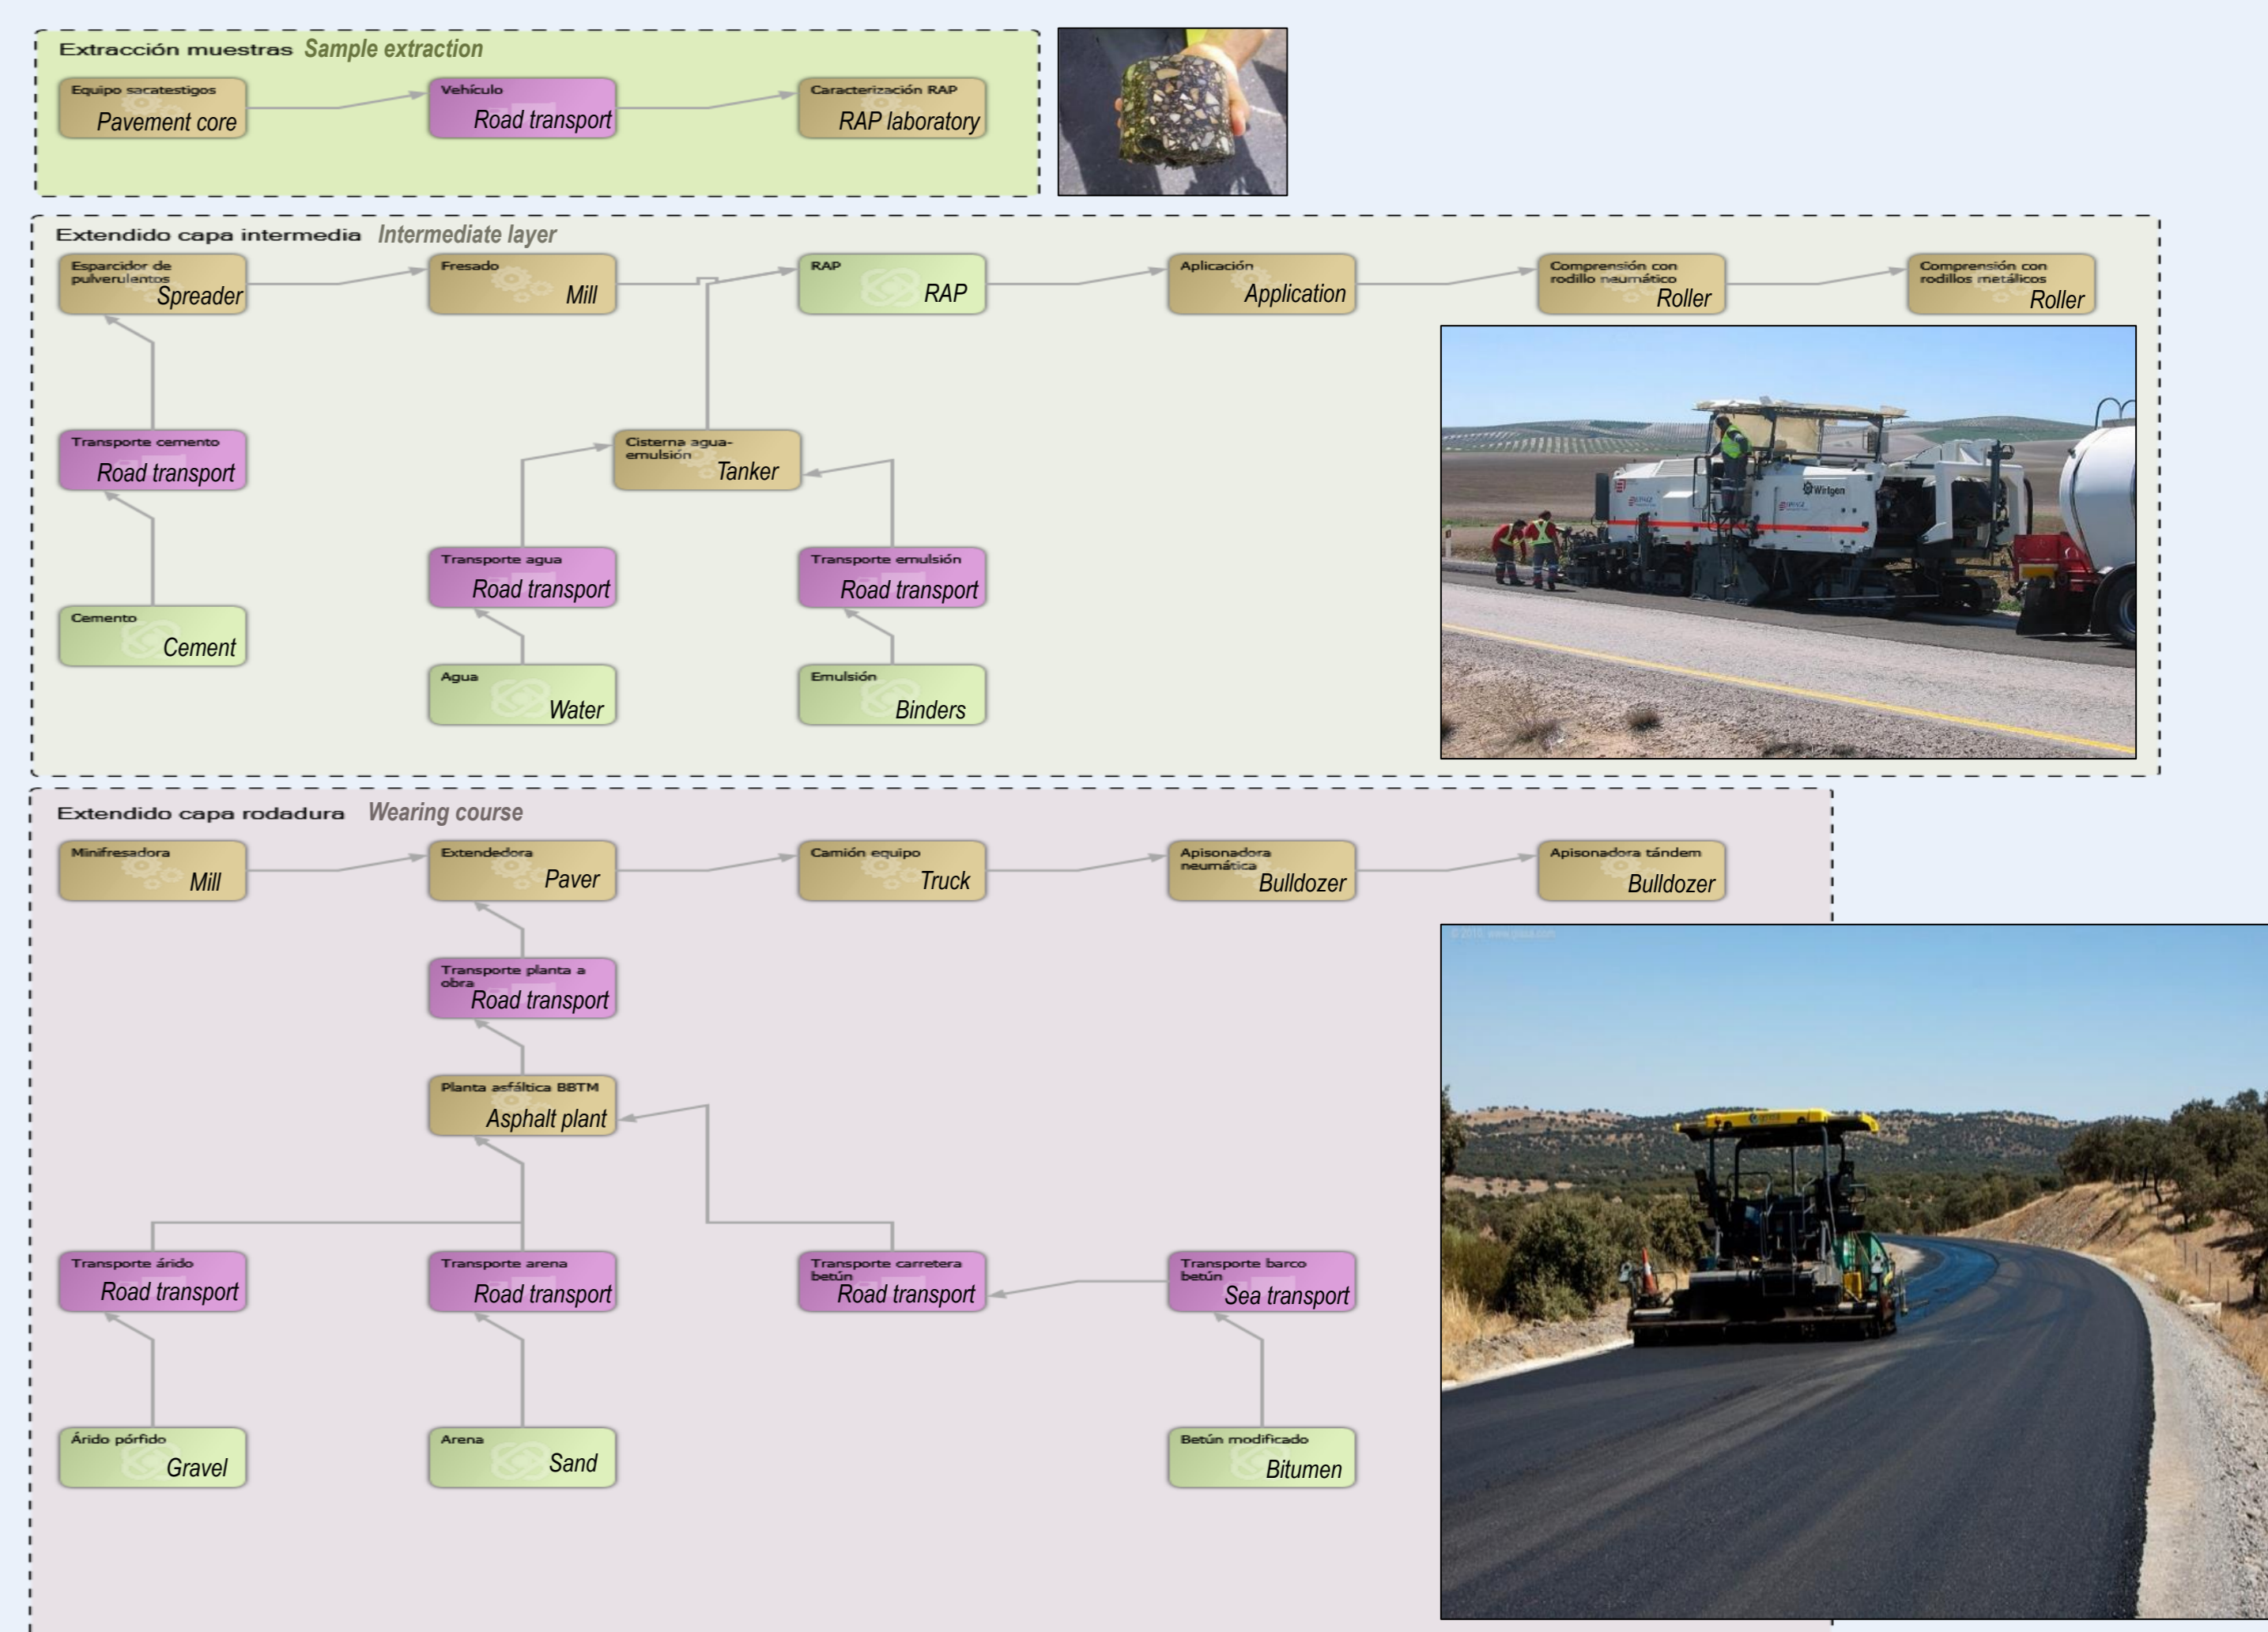
Figure 1. Flow chart of the system boundaries considered in the rehabilitation technique (Air.e screenshot).

Air.e ® Software has been used in order to obtain the results. Figure 1 shows a general flow chart of the process as shown in the software.

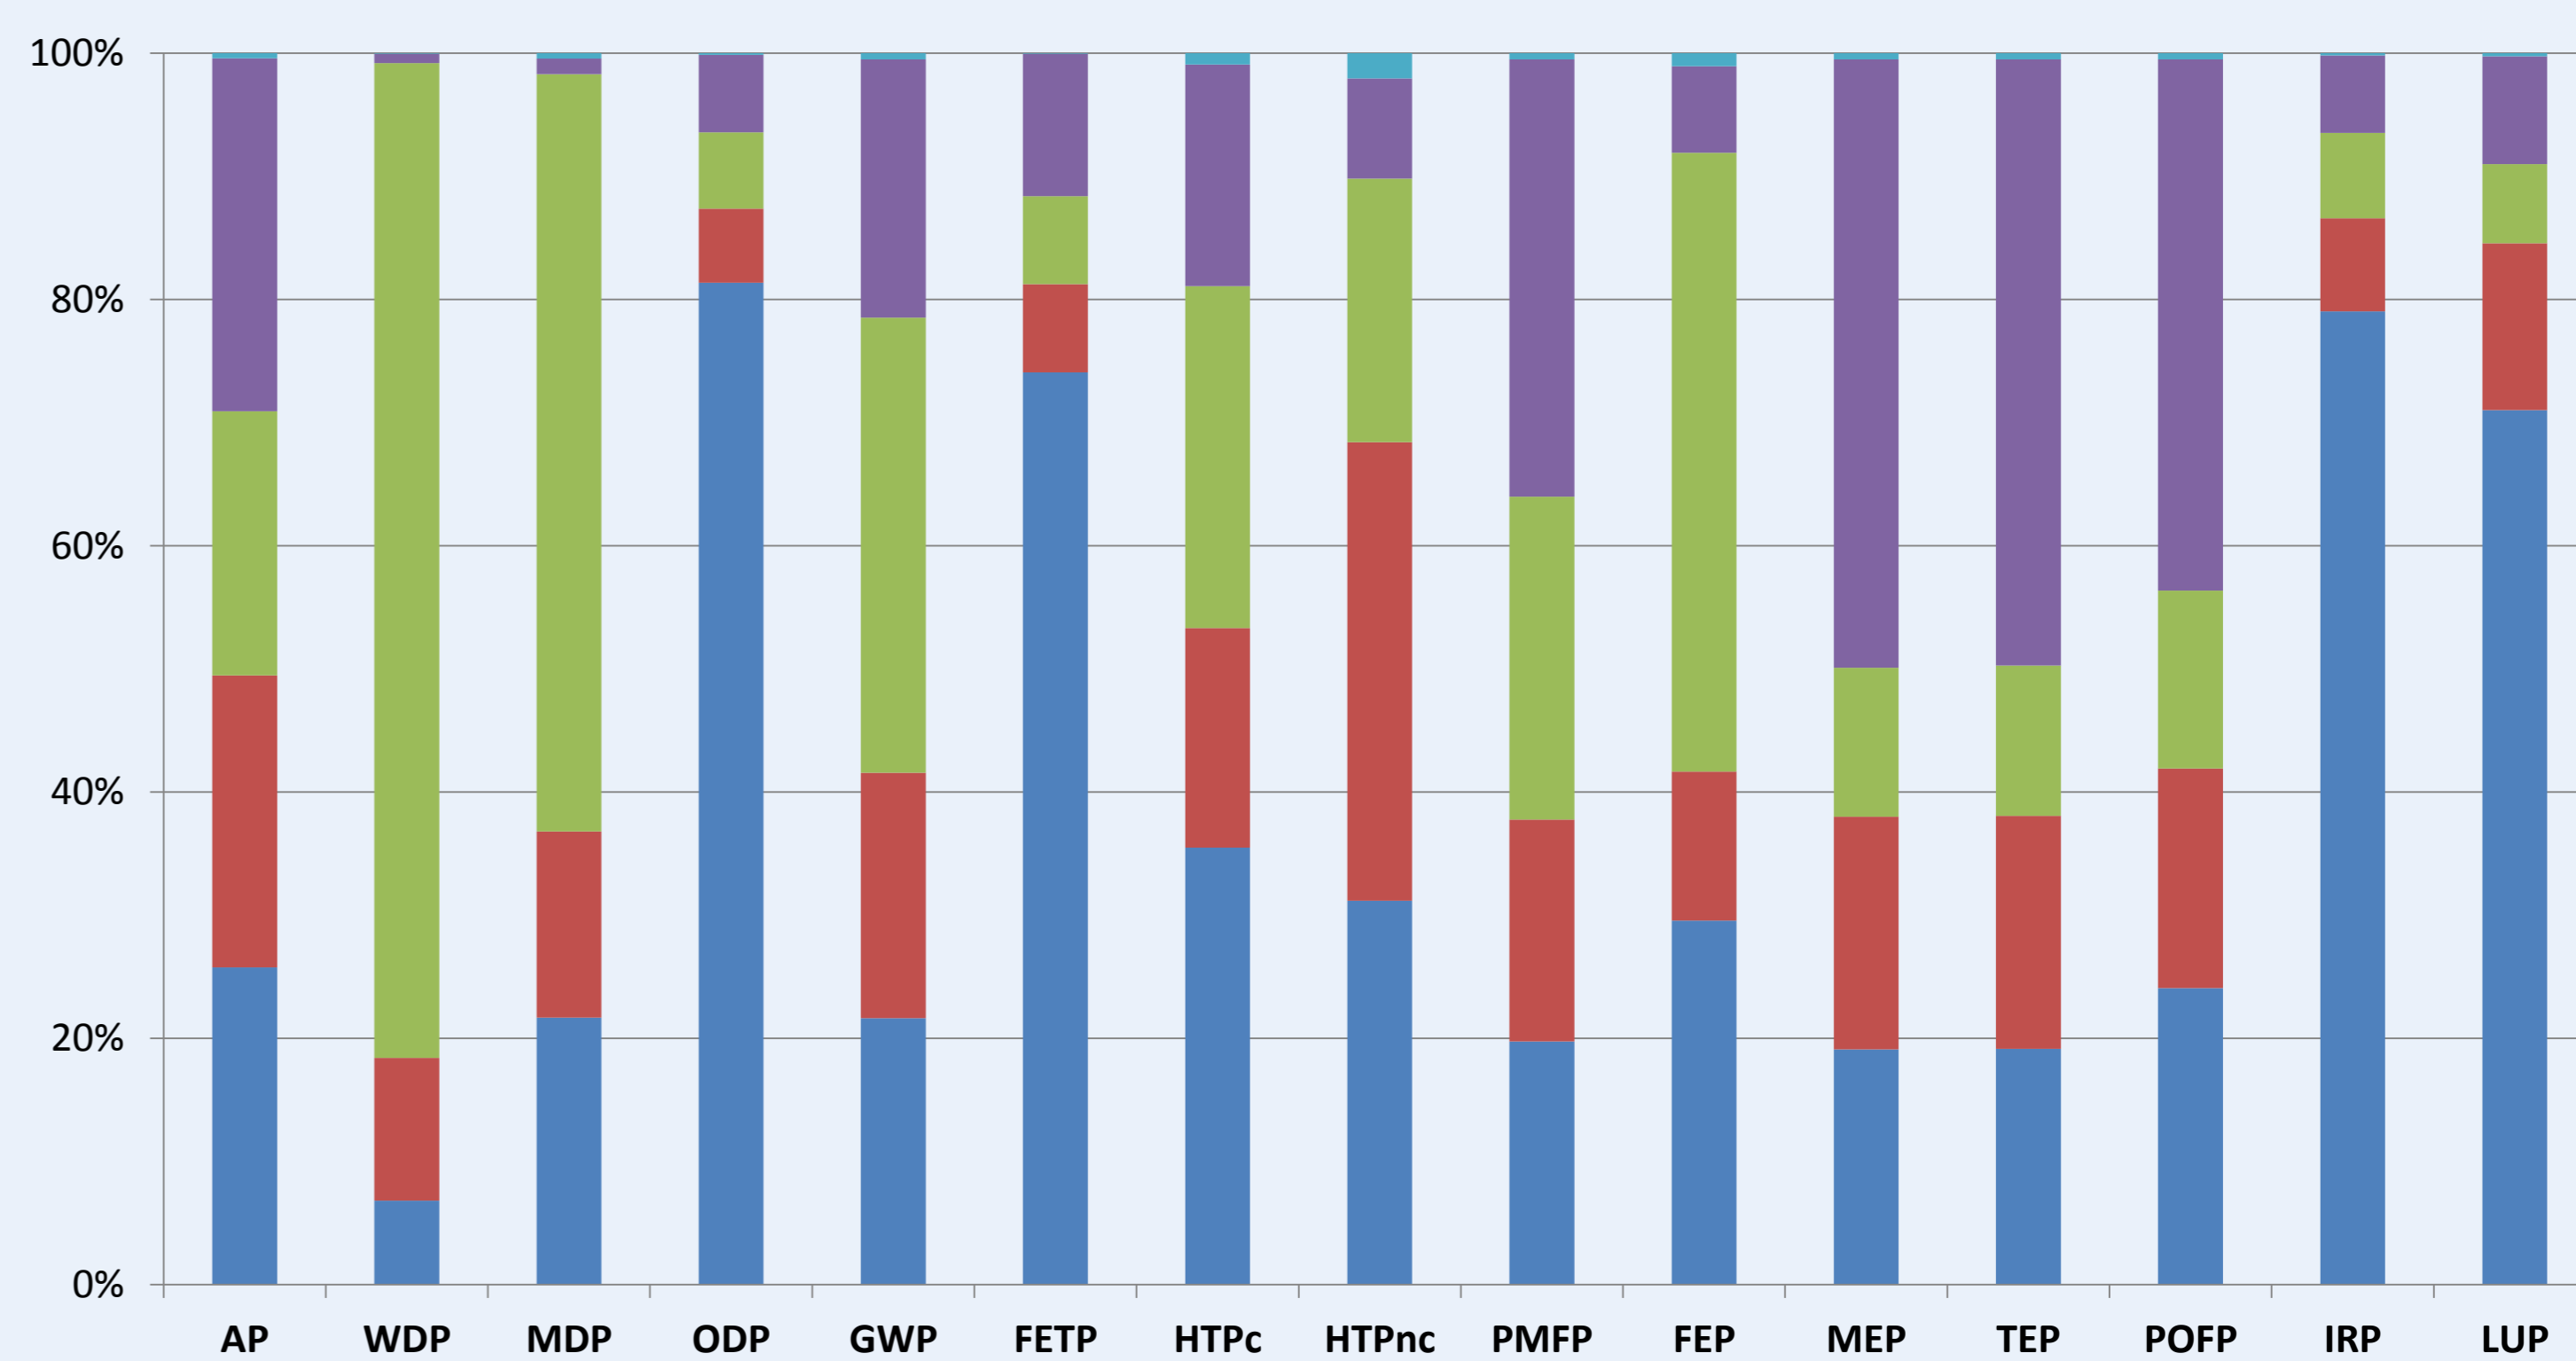
Figure 2. Percentage of contribution of each stage.

Table and Figure 2 show the results of the EF considering the main life cycle stages.

Global results allowed the identification of 'hotspots' in order to consider future actions for reducing the environmental impact, such as the processes of raw materials mining and certain processes of manufacturing materials. Therefore, the cold-*in situ* and the use of RAP are advisable to achieve it.
